## *Fast Facts*

### Waskesiu River Riffle – May 2006

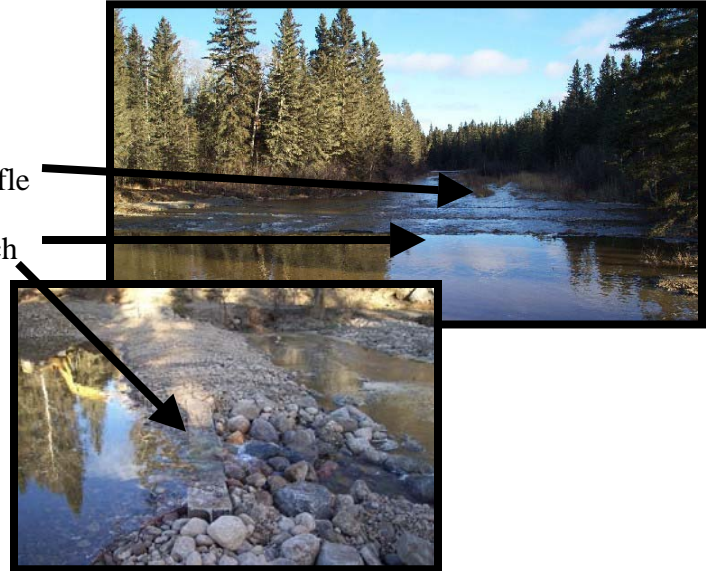
- 3. The riffle was constructed according to an engineered and approved design.**
- The riffle includes a V notch in the middle to allow for fish passage and water flow. The V notch is required for fish passage and is normally a small part of the dam near the centre. The V notch is a 3 metre (m) wide and .3 m deep channel that allows for fish passage.

- 5. As predictable with a newly-constructed structure, settling has resulted in the north end of the riffle (located near the picnic area) and is lower than it should be this spring. The area will be surveyed and more rock will be added to this area to raise it to the appropriate level.**

- 6. This work will take place as part of scheduled project completion and site cleanup work in May 2006.**
- Water flow occurred over the winter and this provided fish access into Waskesiu Lake. Water flow will be monitored on a regular basis throughout 2006.
